CANTILEVERED DETAIL FOR BALCONIES (NO WALL LOAD)

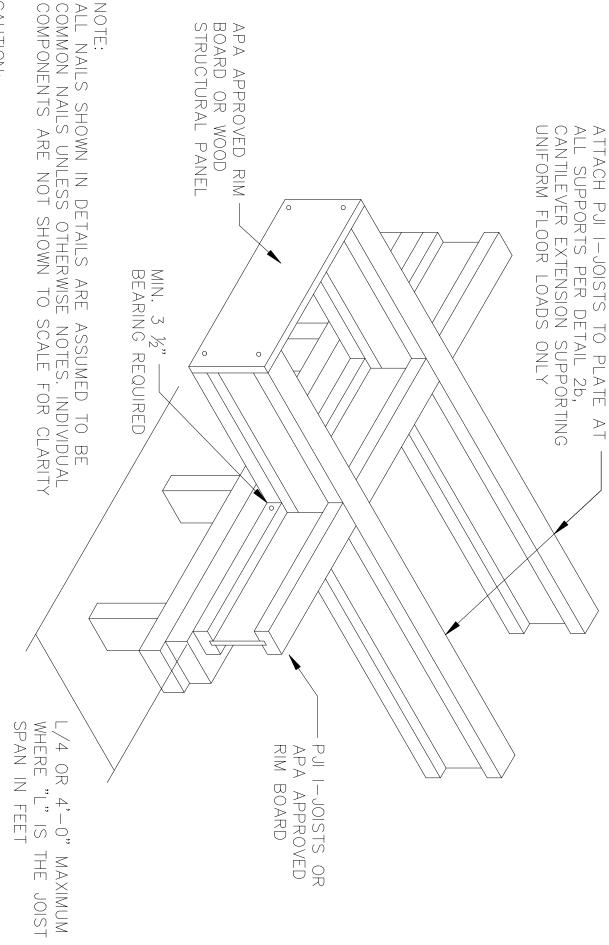
CAUTION:

INTRUSION INTO THE STRUCTURE AND POTENTIAL DECAY OF UNTREATED PJI I—JOIST EXTENSIONS CANTILEVERS FORMED THIS WAY MUST BE CAREFULLY DETAILED TO PREVENT MOISTURE
