## LUMBER CANTILEVERED DETAIL FOR BALCONIES (NO WALL LOAD)

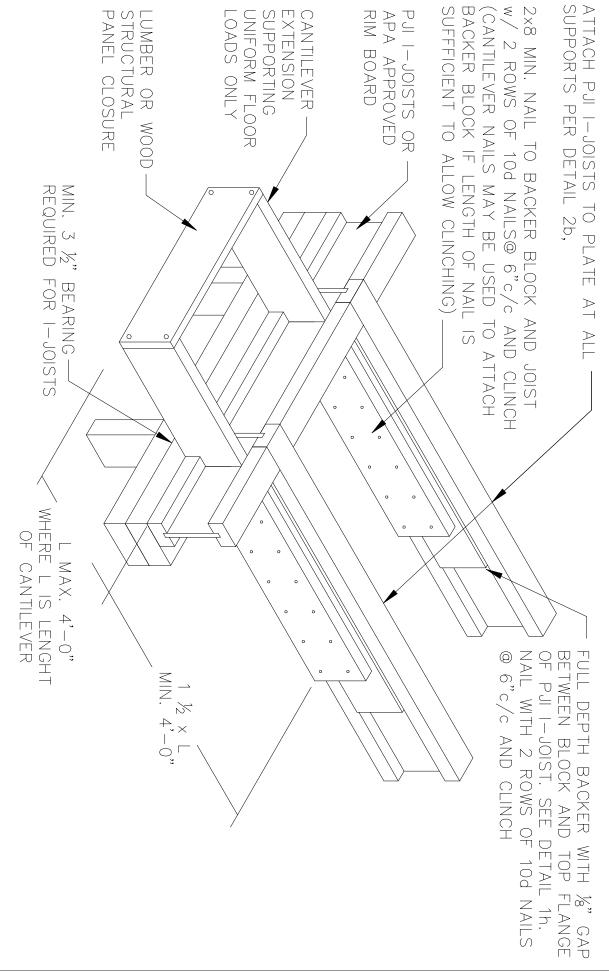
CAUTION:

MOISTURE INTRUSION INTO THE STRUCTURE AND POTENTIAL DECAY CANTILEVERS FORMED THIS WAY MUST BE CAREFULLY DETAILED TO PREVENT
